Housing Inventory Report
City of Mission

December 2003
Data Compiled by:
Diana Weeks

Housing Inventory Report

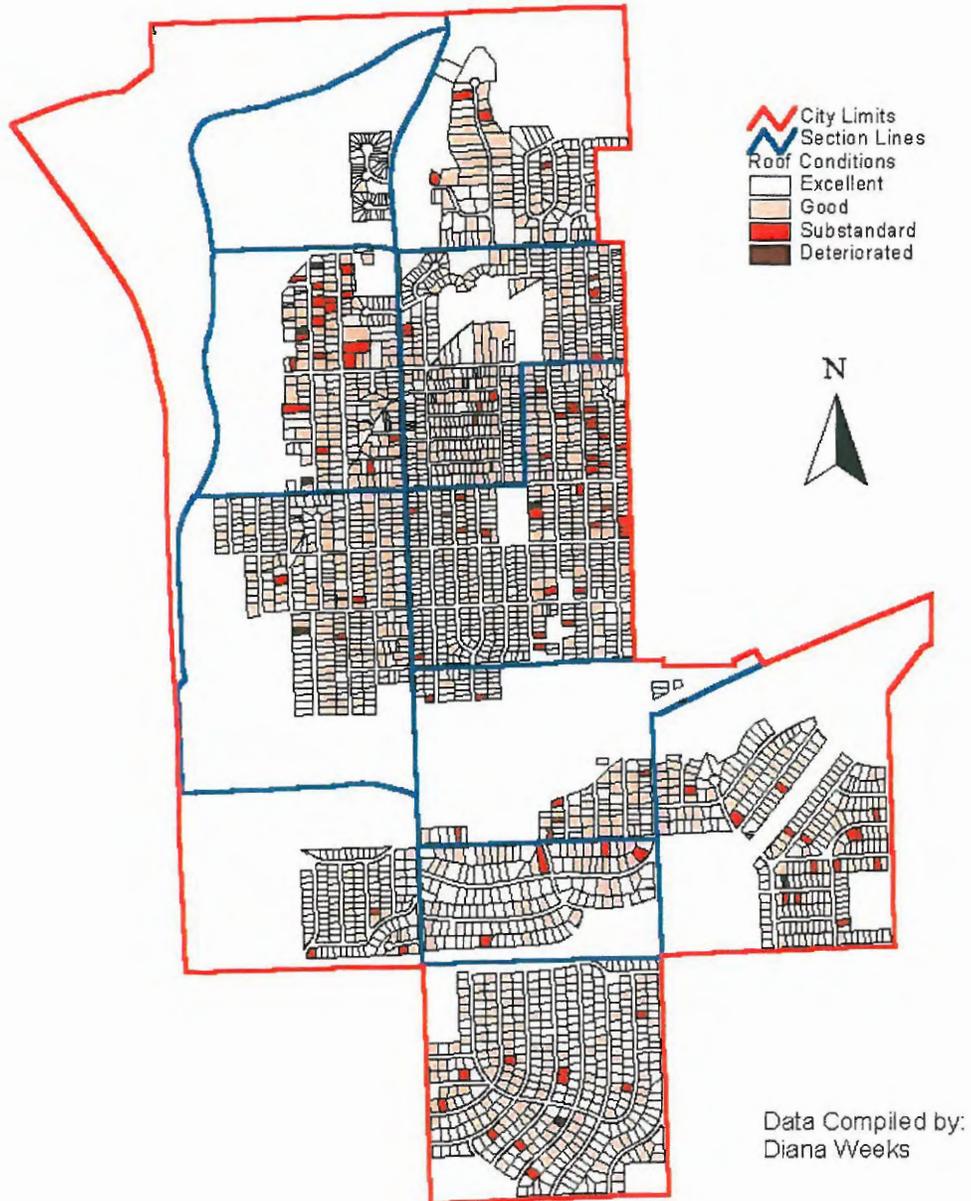
CITY OF MISSION HOUSING INVENTORY ROOF CONDITIONS

Comments: Sections 4 and 12 appear to have lower relative roof conditions. Sections 2, 3, 8, 12 are sections which appear to have higher relative roof conditions.

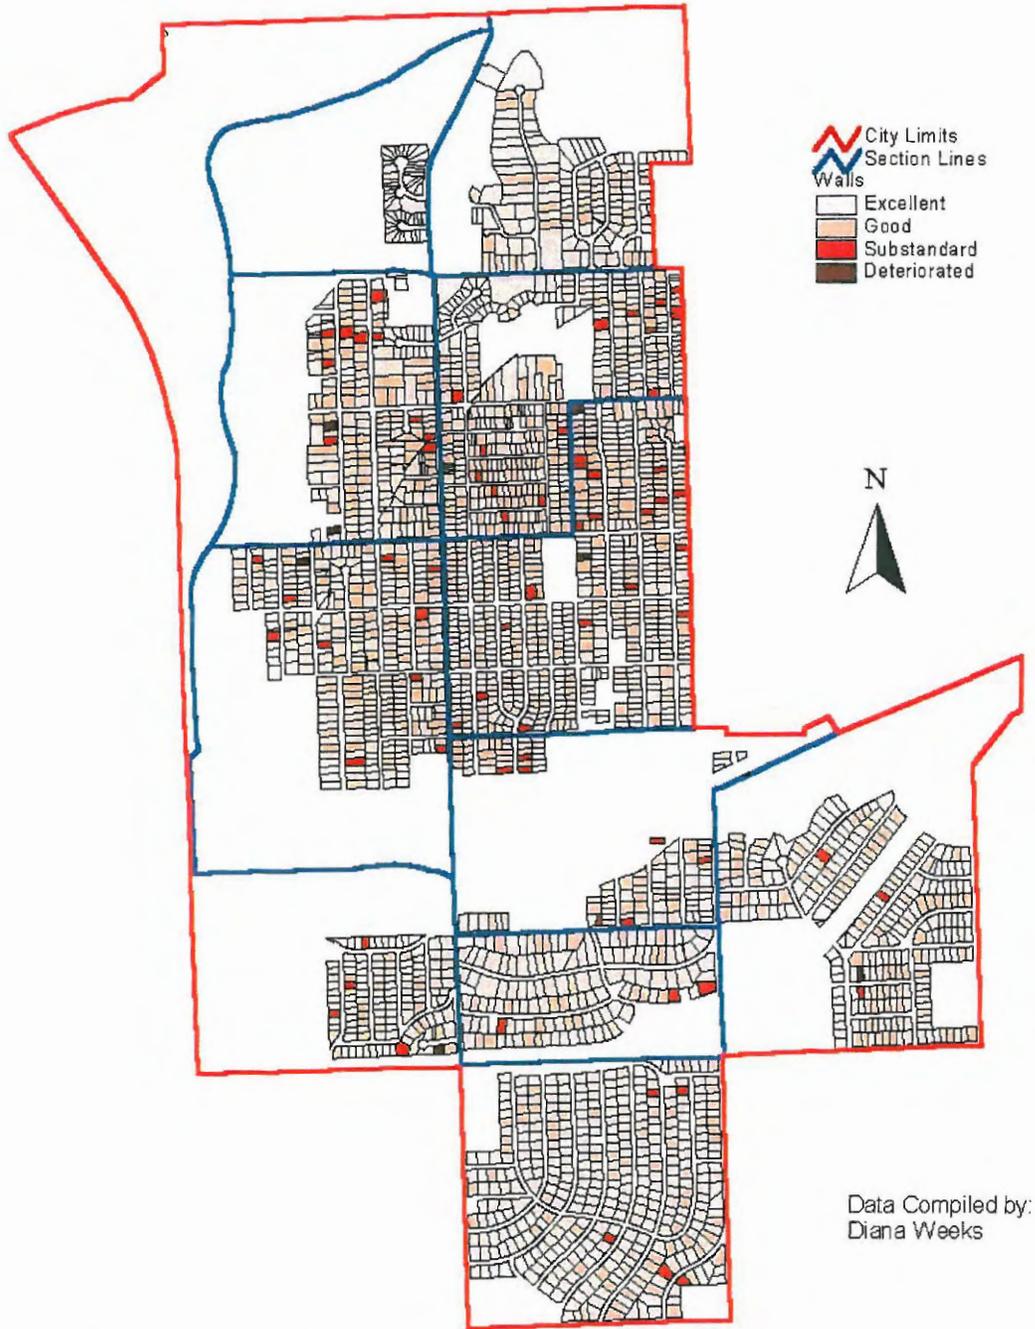
CITY OF MISSION HOUSING INVENTORY FOUNDATION AND WALLS

Comments: Sections 4, 5 and 6 appear to have lower relative conditions of walls and foundations. Sections 2 and 3 are the sections which appear to have the best overall conditions in this category.

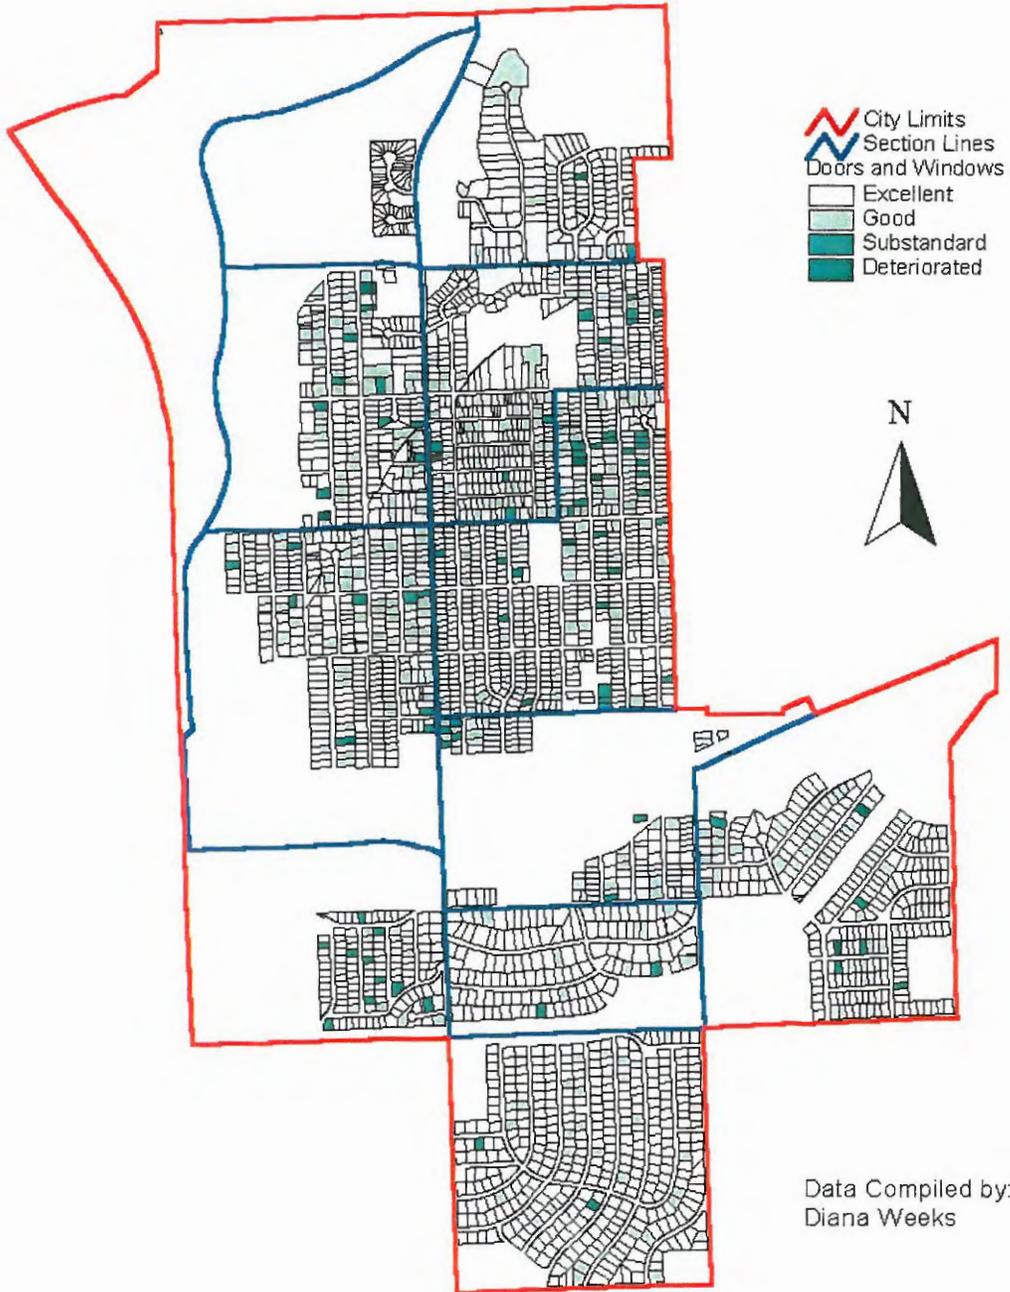
CITY OF MISSION HOUSING INVENTORY DOORS AND WINDOWS

Comments: Section 4 appears to have the lowest relative conditions of this Doors and Windows. Sections 2 and 3 are the sections which appear to have the best overall conditions in this category.

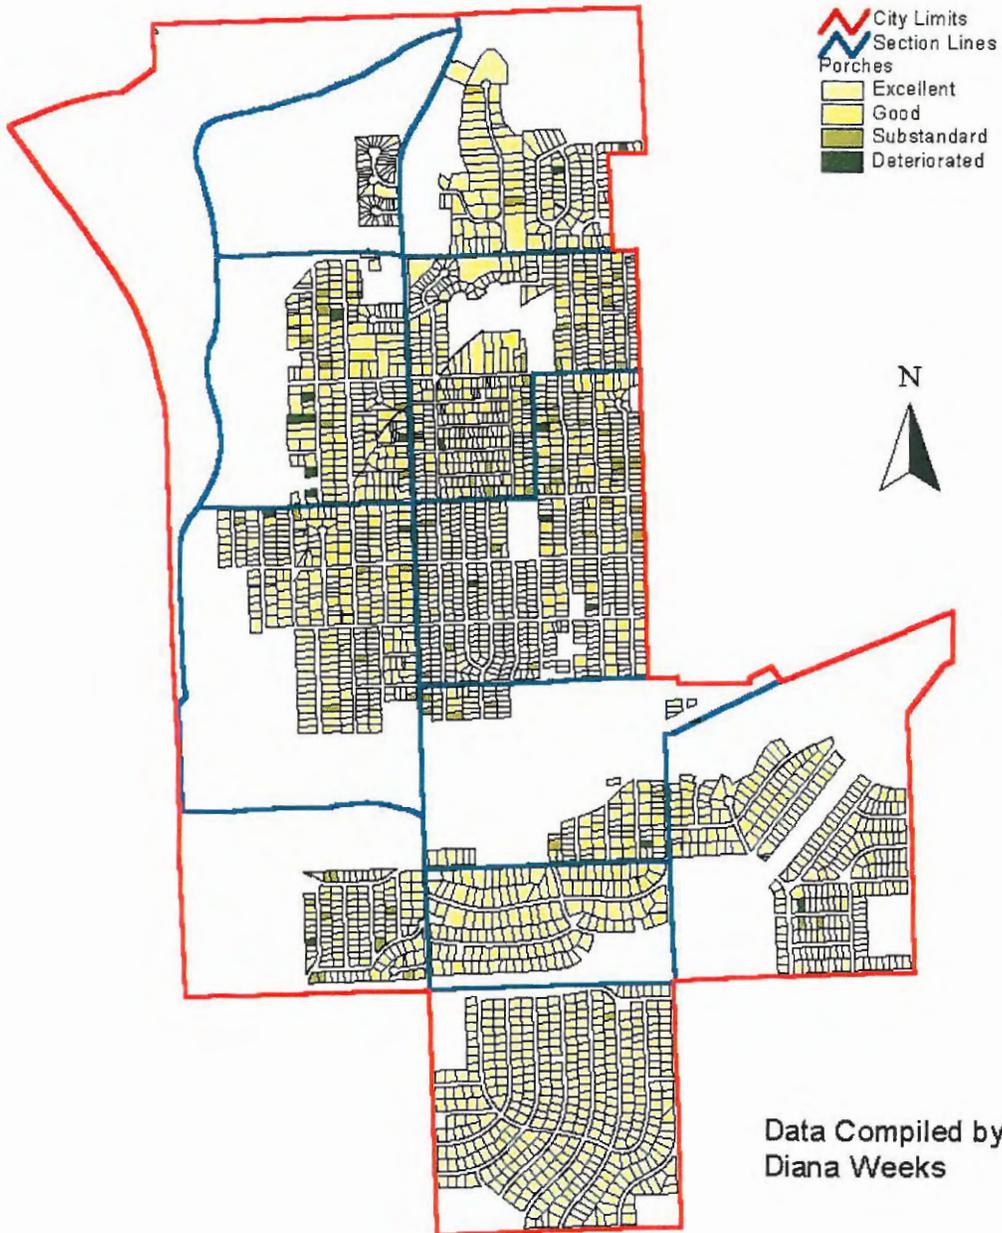
CITY OF MISSION HOUSING INVENTORY PORCHES AND STOOPS

Comments: Sections 4 and 6 appear to have lower relative conditions of Porches and Stoops. Sections 2 and 3 are the sections which appear to have the best overall conditions in this category.

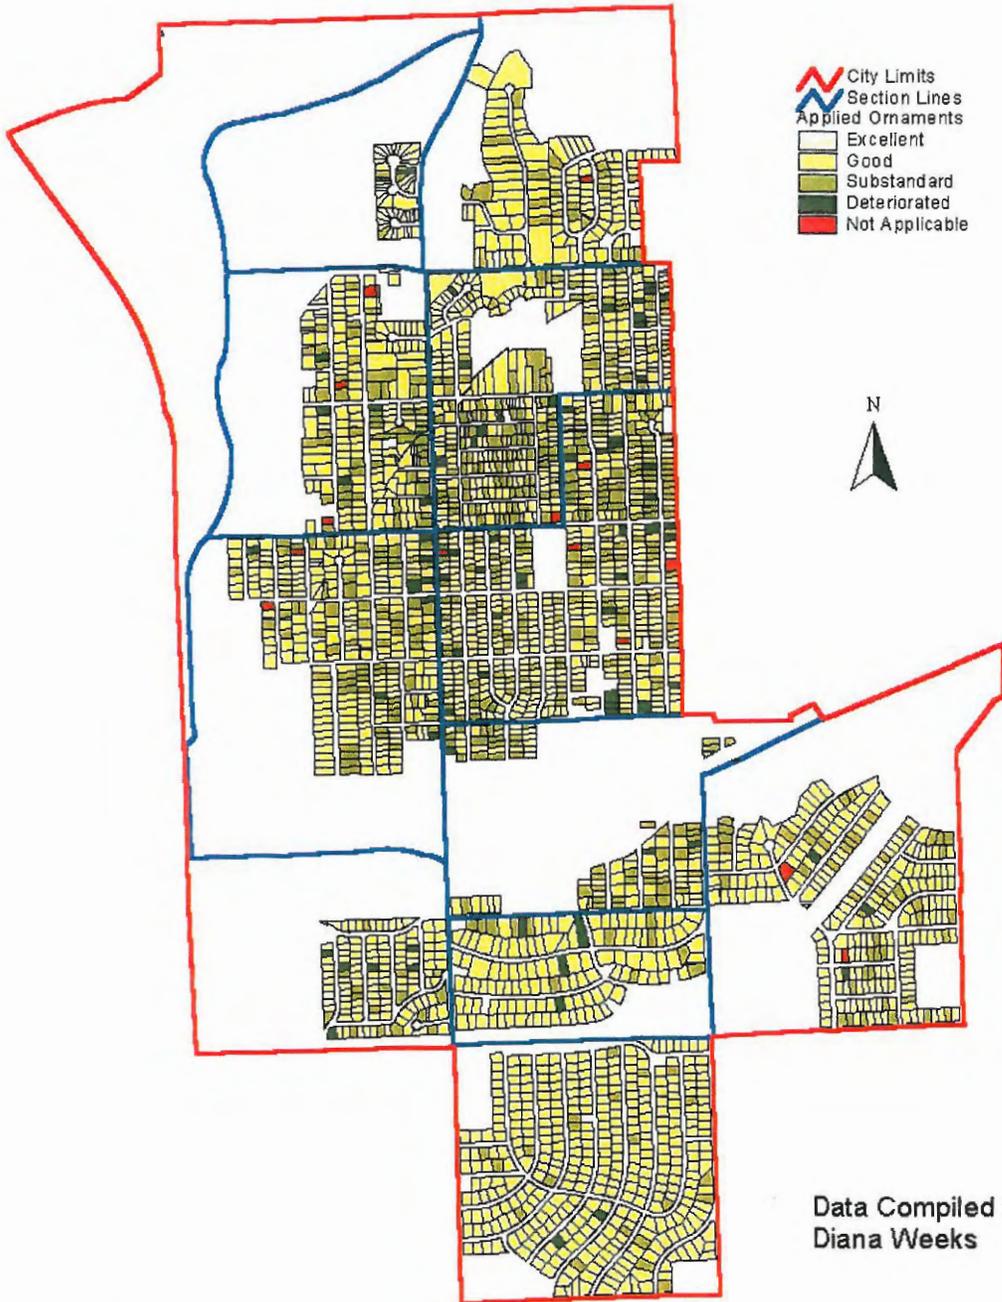
CITY OF MISSION HOUSING INVENTORY APPLIED ORNAMENTS

Comments: Section 4 appears to have lower relative conditions of Applied Ornaments. Section 2 is the section which appears to have the best overall conditions in this category.

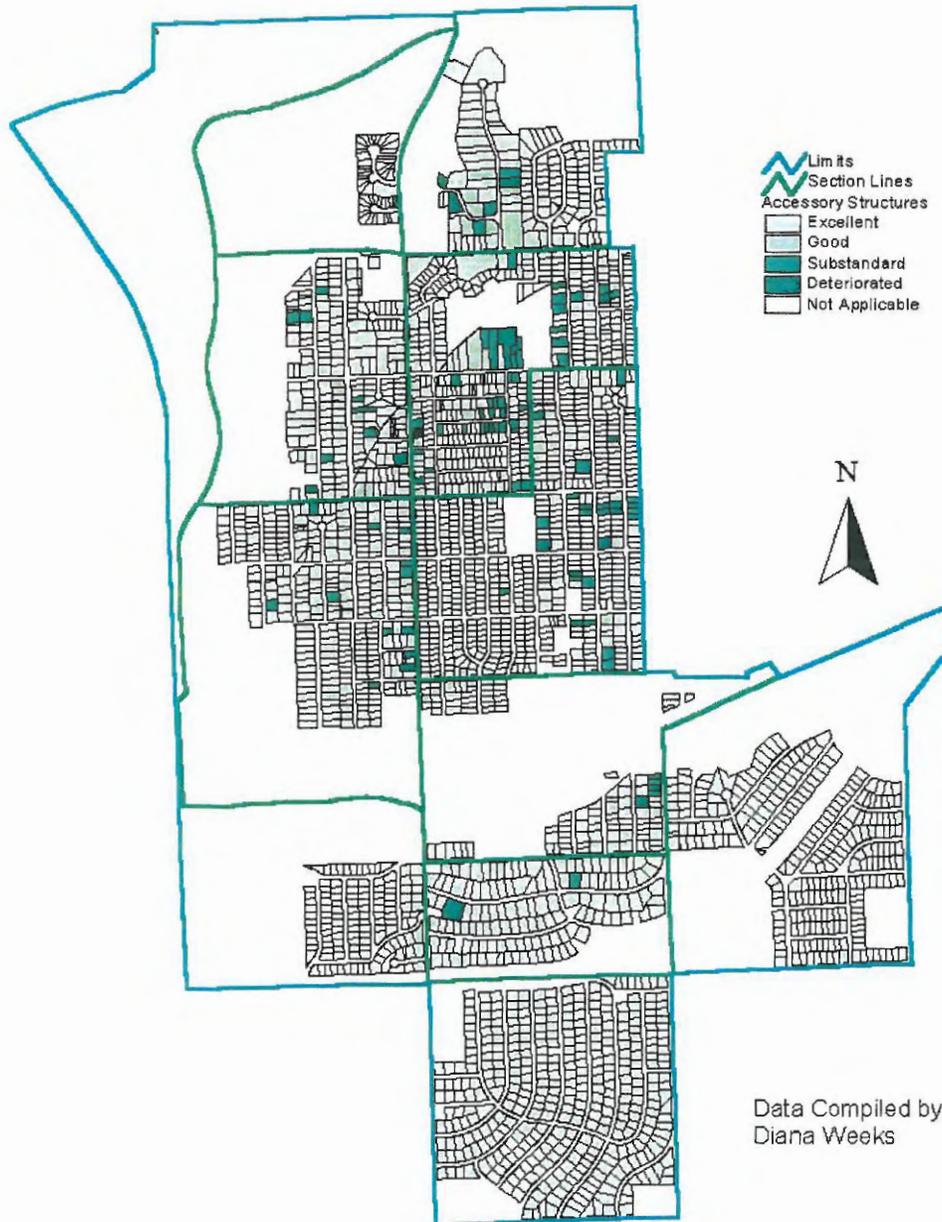
CITY OF MISSION HOUSING INVENTORY ACCESSORY STRUCTURES

Comments: Sections 4 and 6 appear to have lower relative conditions of Accessory Structures. Sections 1, 2, 3 and 12 are the sections which appear to have the best overall conditions in this category.

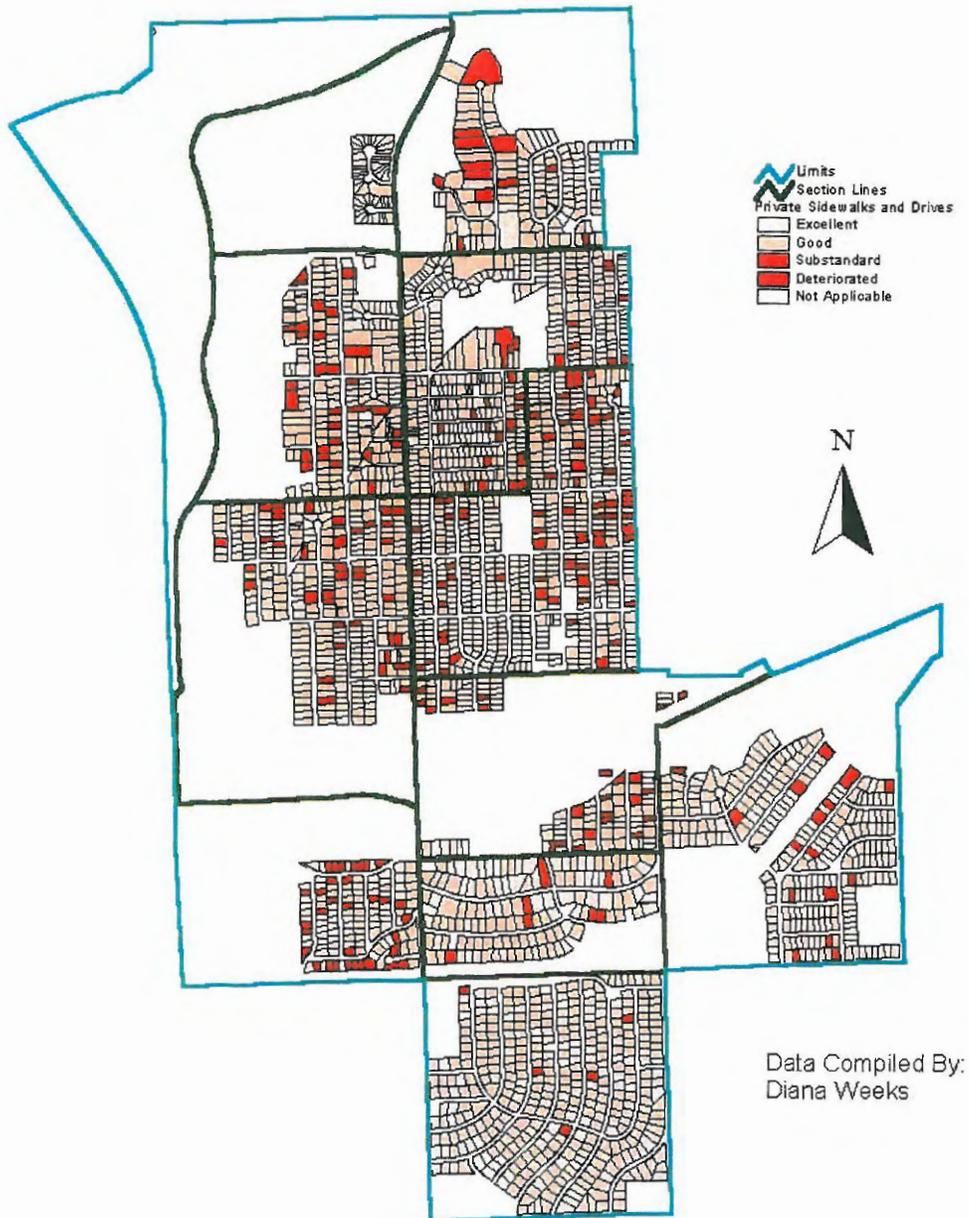
CITY OF MISSION HOUSING INVENTORY PRIVATE SIDEWALKS AND DRIVES

Comments: Sections 4, 3 and 12 appear to have lower relative conditions of Driveways and Private Sidewalks. Sections 2 and 3 are the sections which appear to have the best overall conditions in this category.

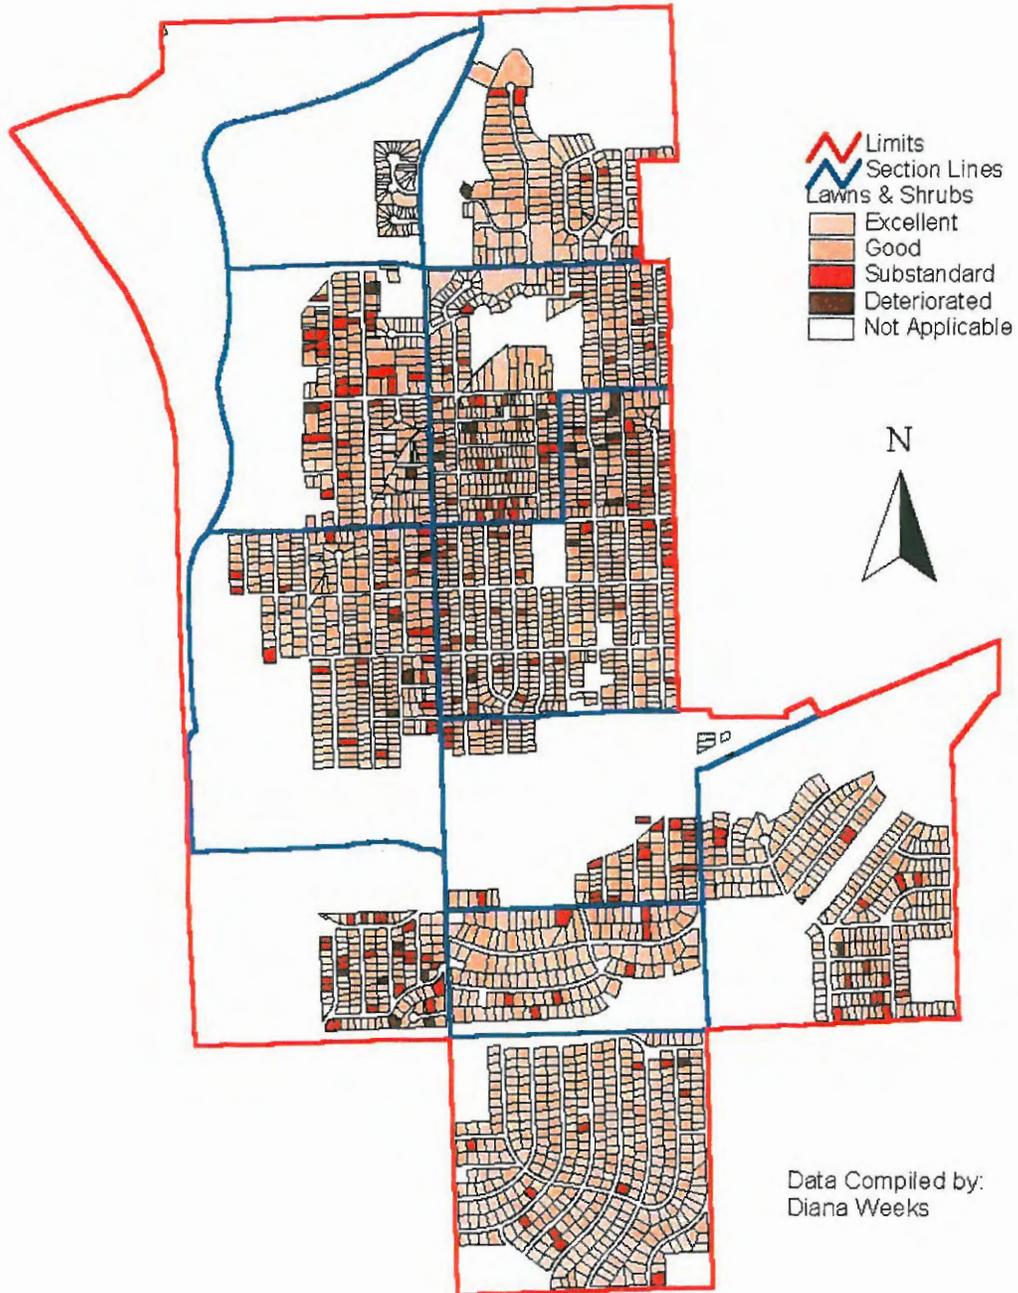
CITY OF MISSION HOUSING INVENTORY LAWNS & SHRUBS

Comments: Sections 4 and 12 appear to have lower relative conditions of Lawns and Shrubs. Sections 2, 3 and 8 are the sections which appear to have the best overall conditions in this category.

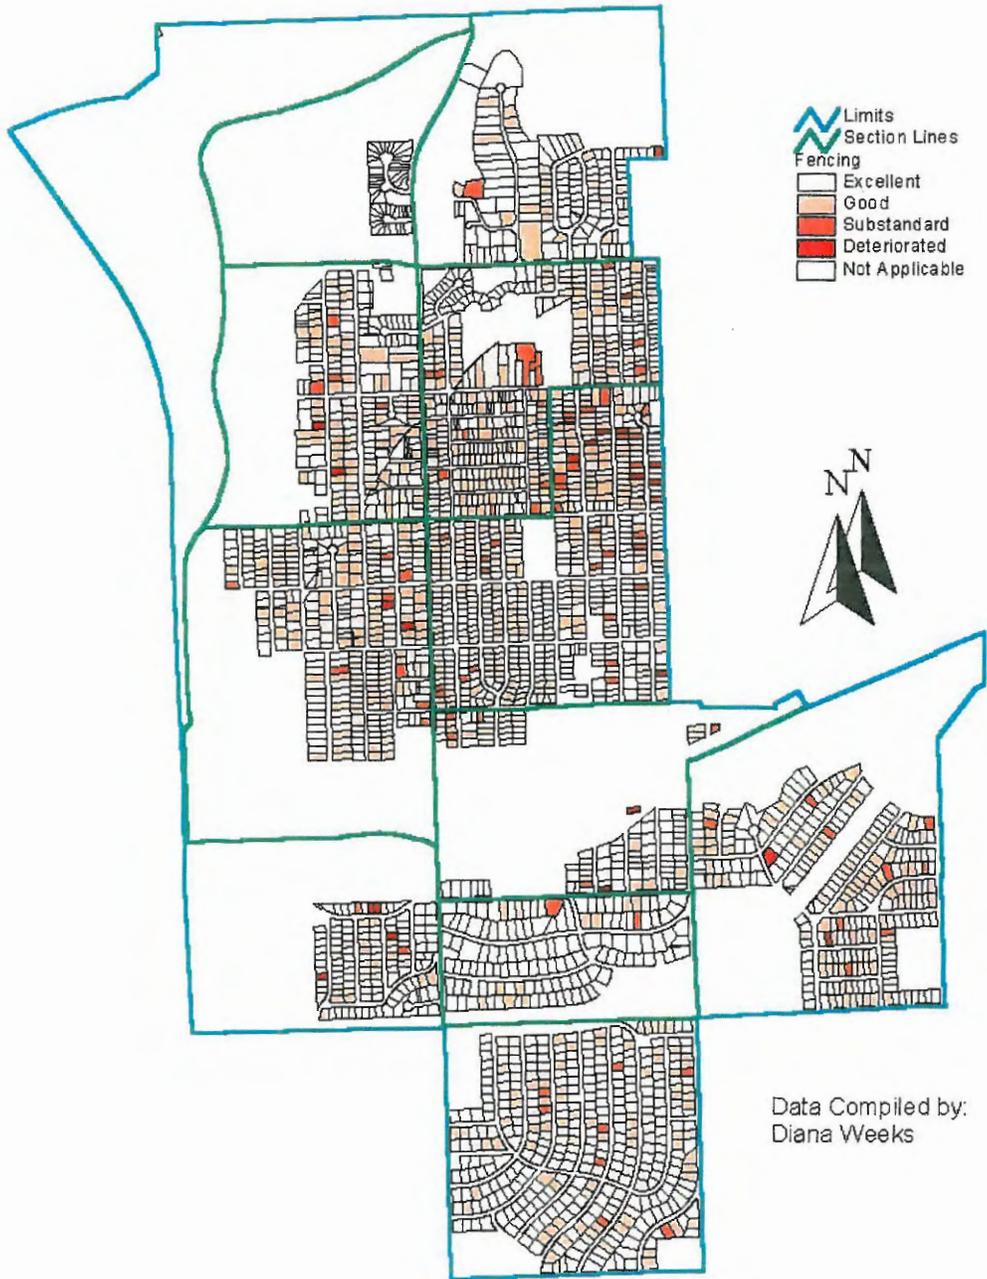
CITY OF MISSION HOUSING INVENTORY FENCING

Comments: Sections 1, 5, 6 and 11 appear to have lower relative conditions of Fencing foundations. Sections 3, 7 and 8 are the sections which appear to have the best overall conditions in this category.

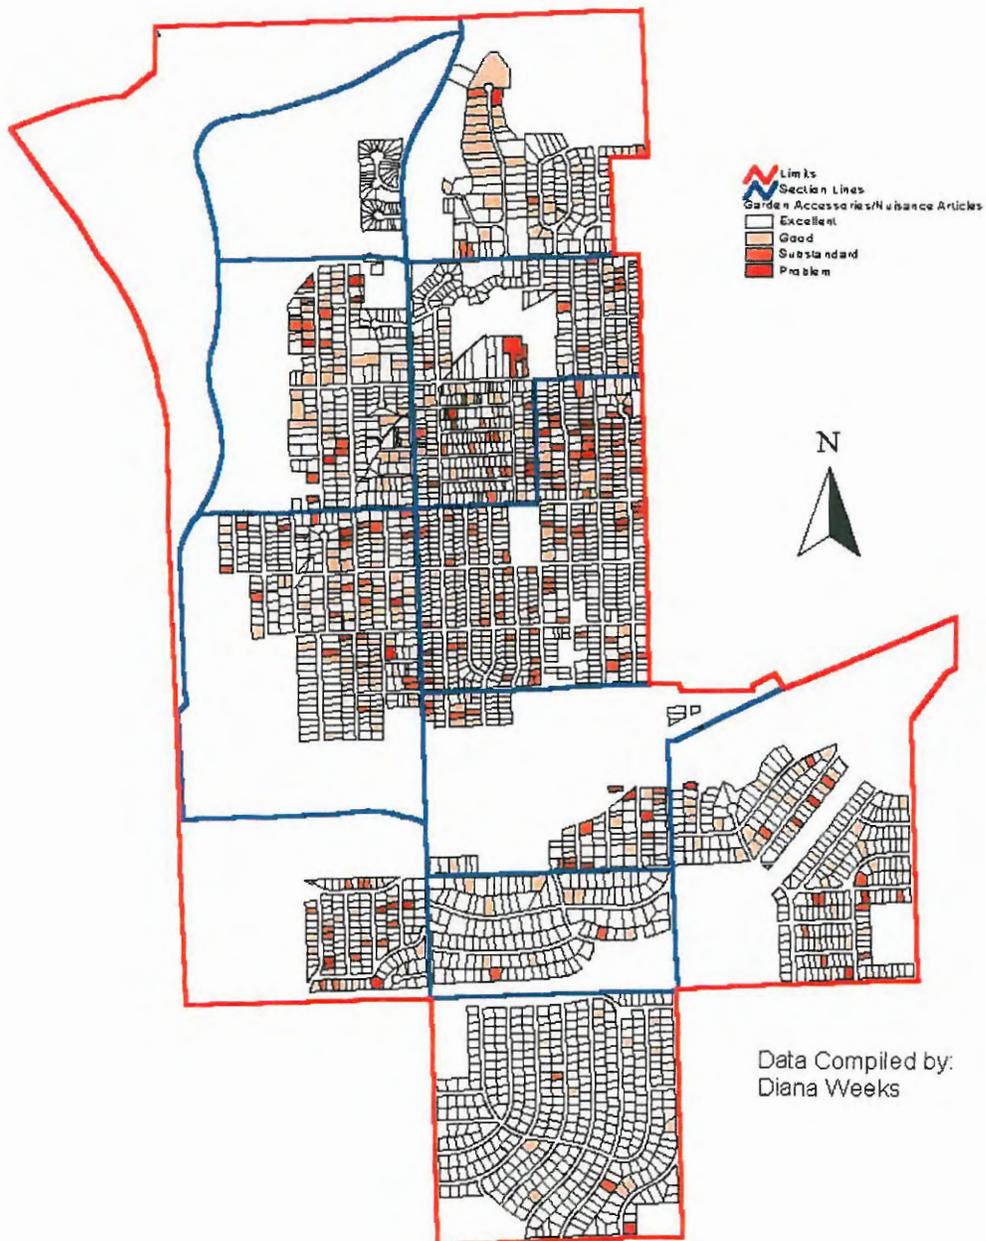
CITY OF MISSION HOUSING INVENTORY GARDEN ACCESSORIES/NUISANCE ARTICLES

Comments: Section 4 appears to have lower relative conditions of Garden Items and Nuisance Articles. Sections 2, 3 and 8 are the sections which appear to have the best overall conditions in this category.

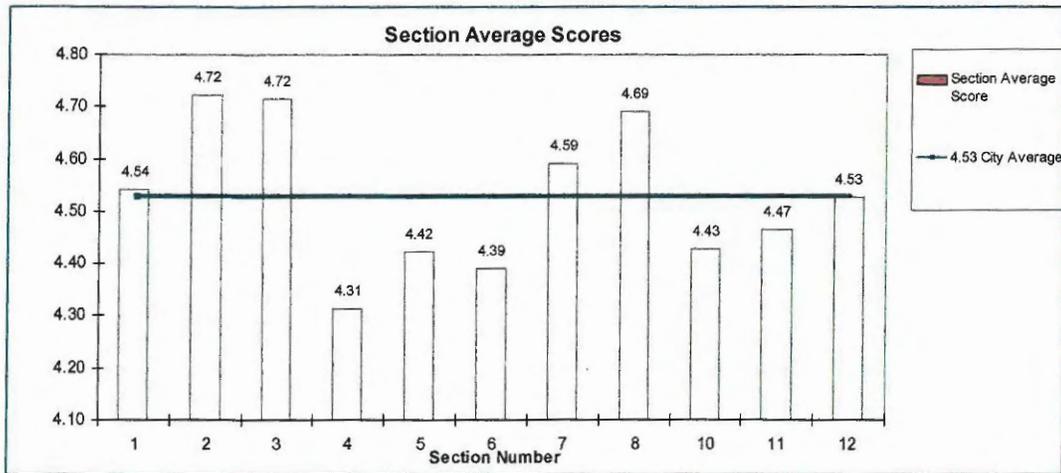
4) Discussion of overall housing conditions per City Section.

It can be noted, that the Sections with the highest overall average scores are sections 2, 3 and 8. Sections with lower scores are 4, 5, 6 and 10. Section 8 differs from other sections because of the small number of units, all of which are duplexes, and many of which are only considered by the County to be one 'parcel', even though they may consist of two residential units.
