Housing Inventory Report
City of Mission

December 2003
Data Compiled by:
Diana Weeks

Housing Inventory Report

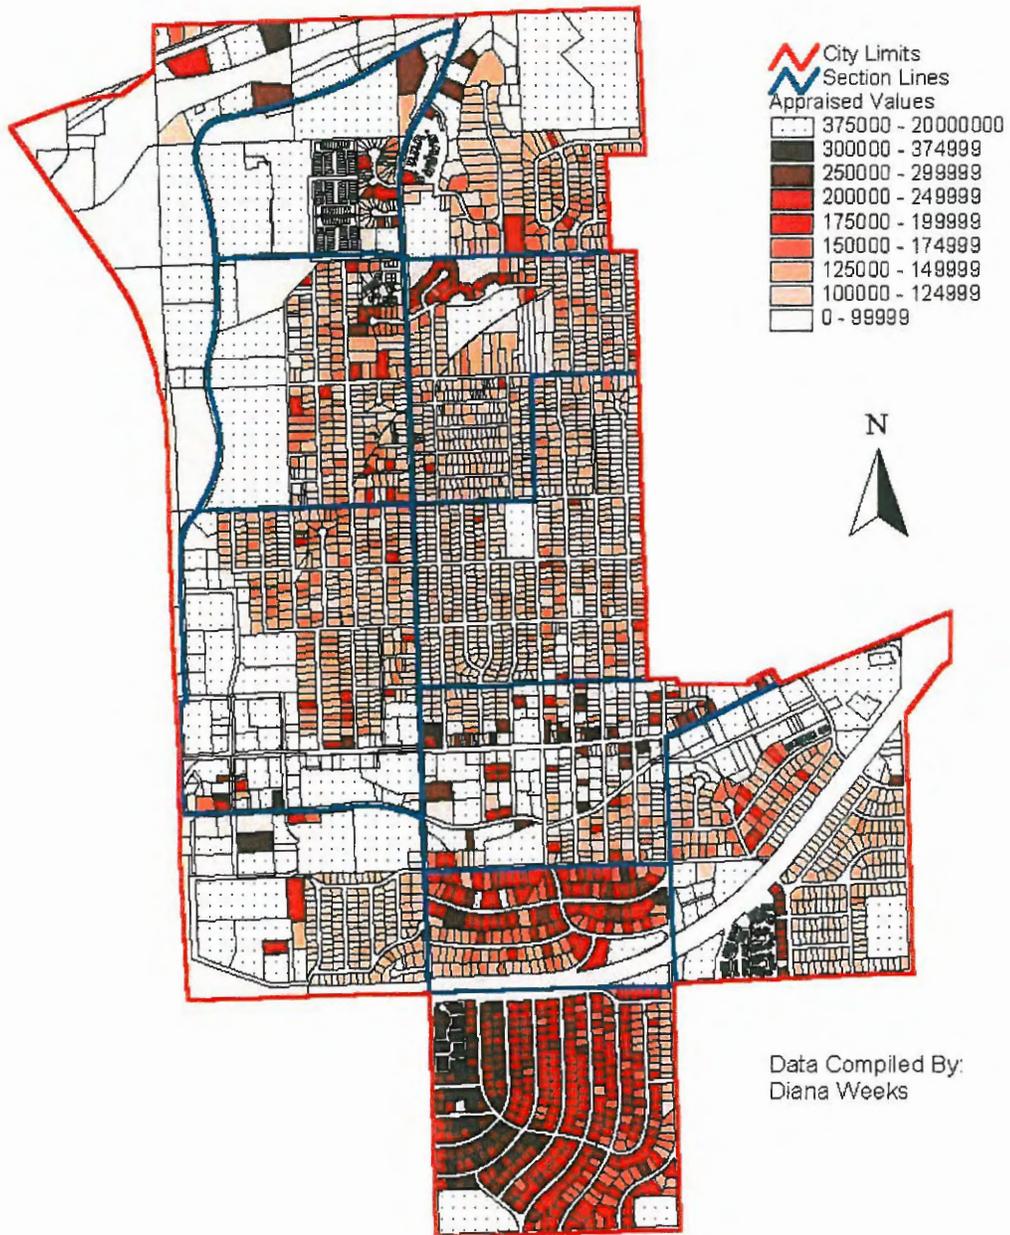
CITY OF MISSION HOUSING INVENTORY APPRAISED VALUES

Comments: This map illustrates appraised values (2002 Data obtained from the Johnson County Appraiser's Office). Areas of higher values are Sections 2 (Millhaven) and 3 (Countryside) (215,298 and 189,615 respectively). Areas of overall lower values are Sections 4, 5 and 12 (116,695, 117,290, and 119,596 respectively).

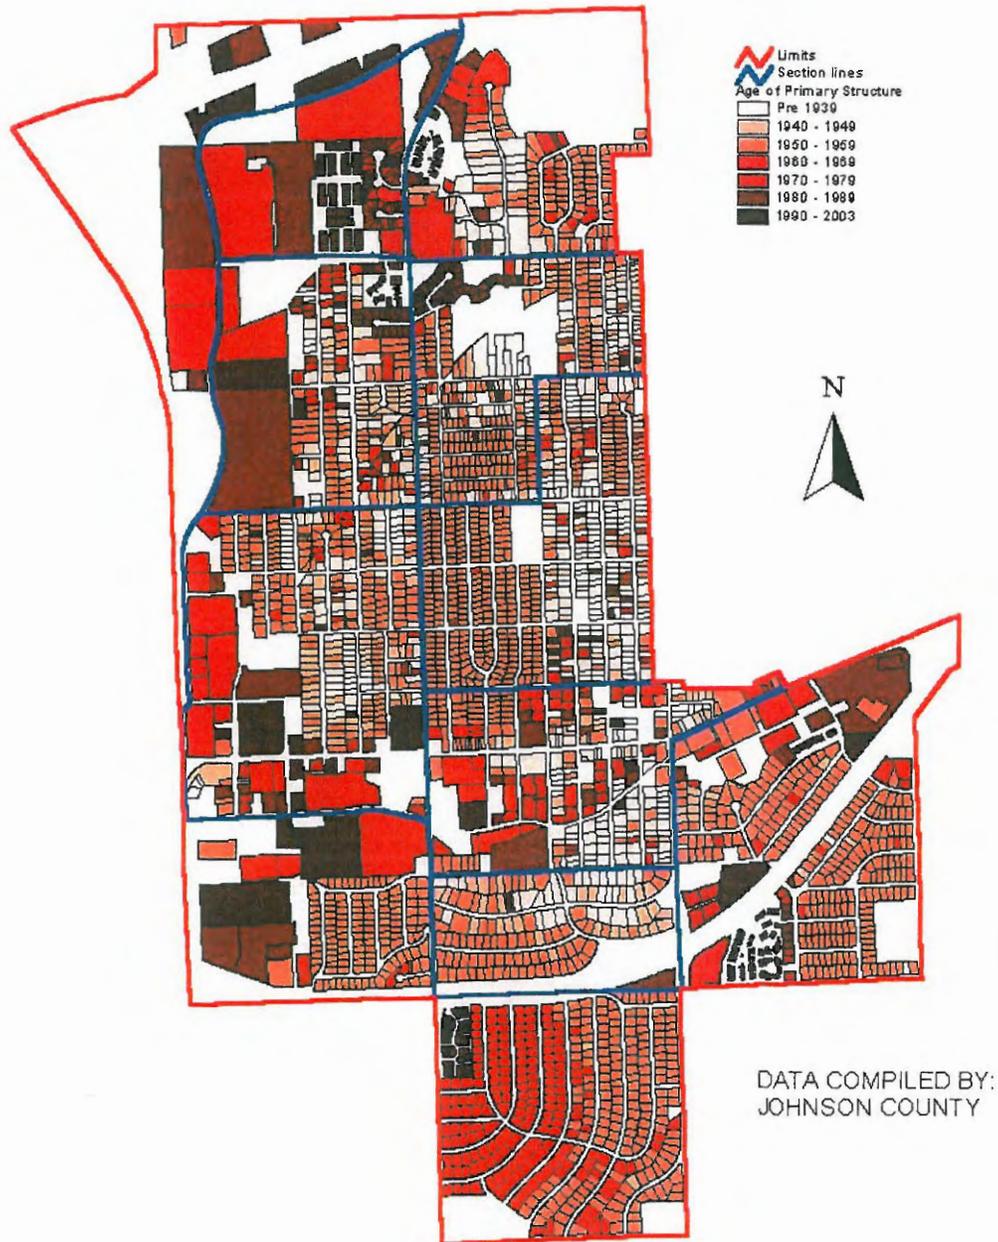
CITY OF MISSION HOUSING INVENTORY AGE OF PRIMARY STRUCTURES

Comments: This map illustrates the age of primary structures at each property (2002 Data obtained from the Johnson County Appraiser's Office). Pre 1939 structures are concentrated in Sections 4 and 5, even though significant infill is becoming apparent in these areas, as well as areas north of 53rd Street. The most homogenous area perhaps is Section 2, where most housing was built in the 1950's and 1960's.

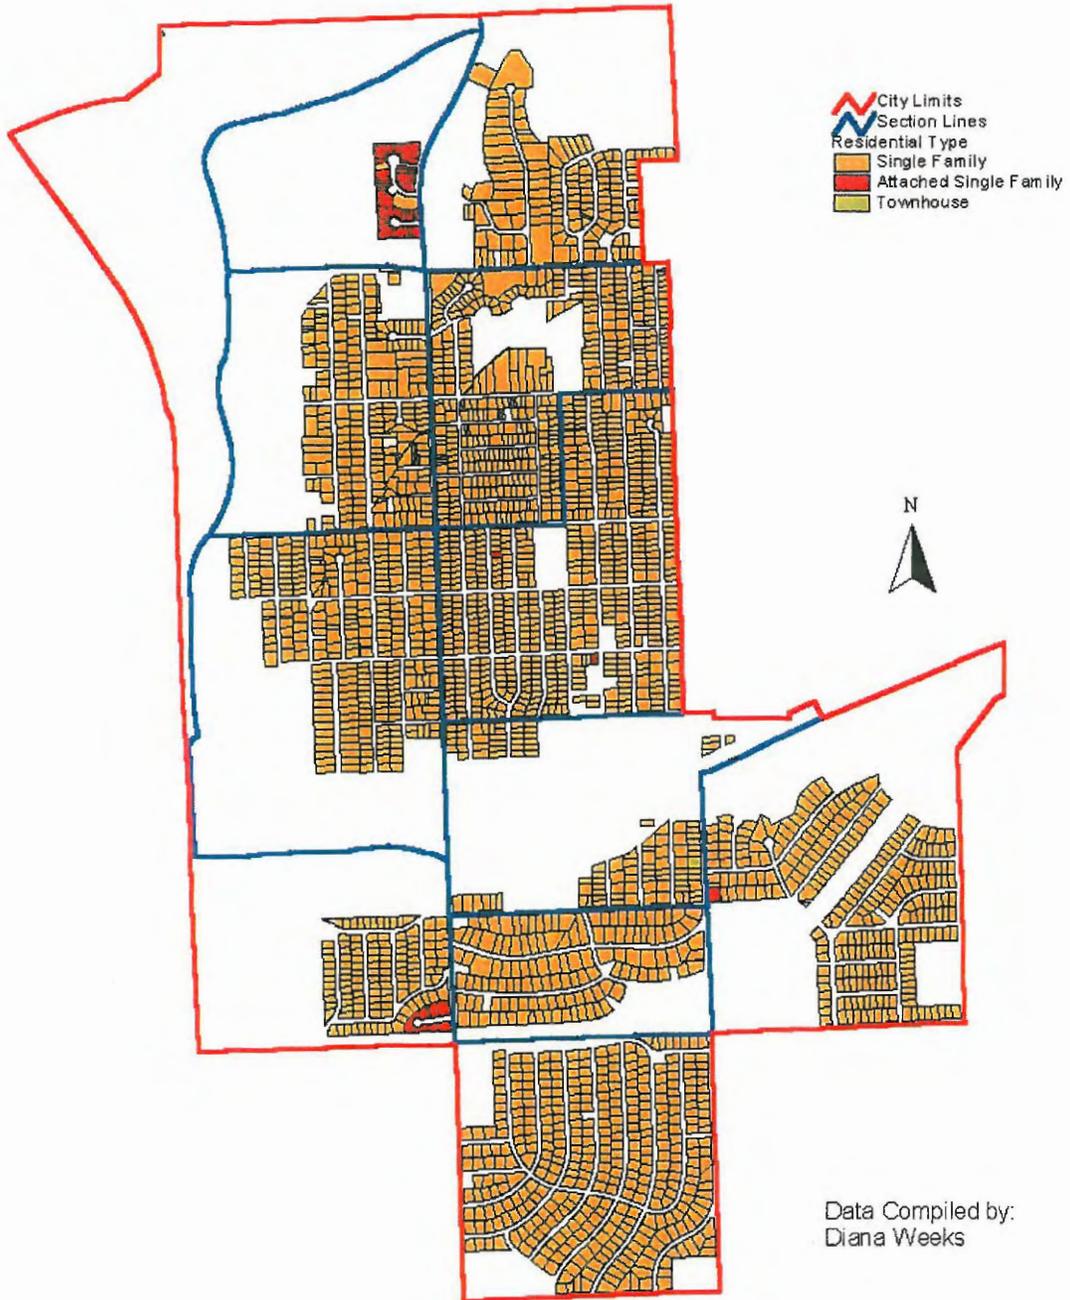
CITY OF MISSION HOUSING INVENTORY RESIDENTIAL TYPE

Comments: This map illustrates the abundance of single family structures in the City of Mission. A few existing 'attached' single family structures are identified.

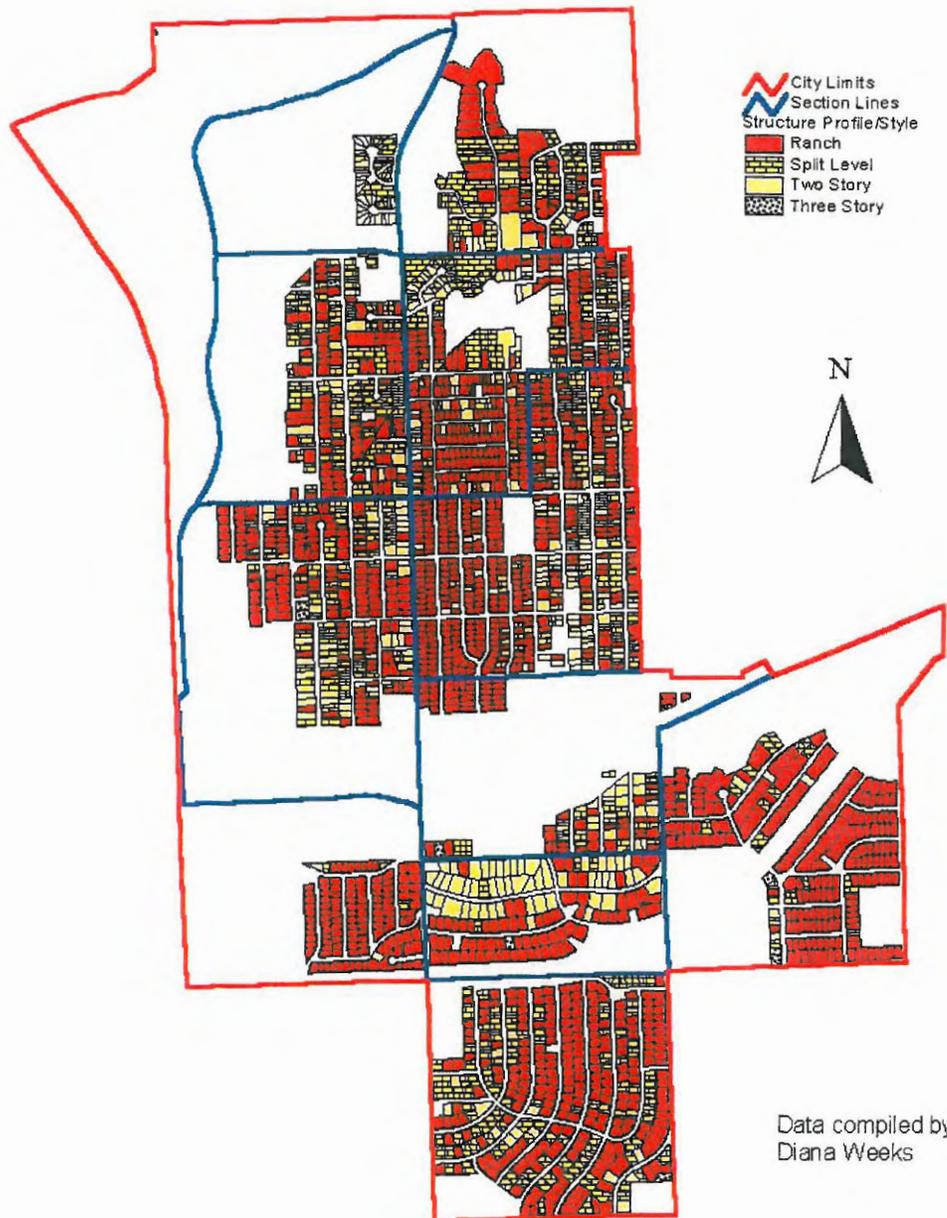
CITY OF MISSION HOUSING INVENTORY STRUCTURE PROFILE

Comments: This map illustrates the structure profile of primary structures. Dominant structure profile styles are ranch and split-levels. Two story homes are also dominant in Section 3 (Countryside).

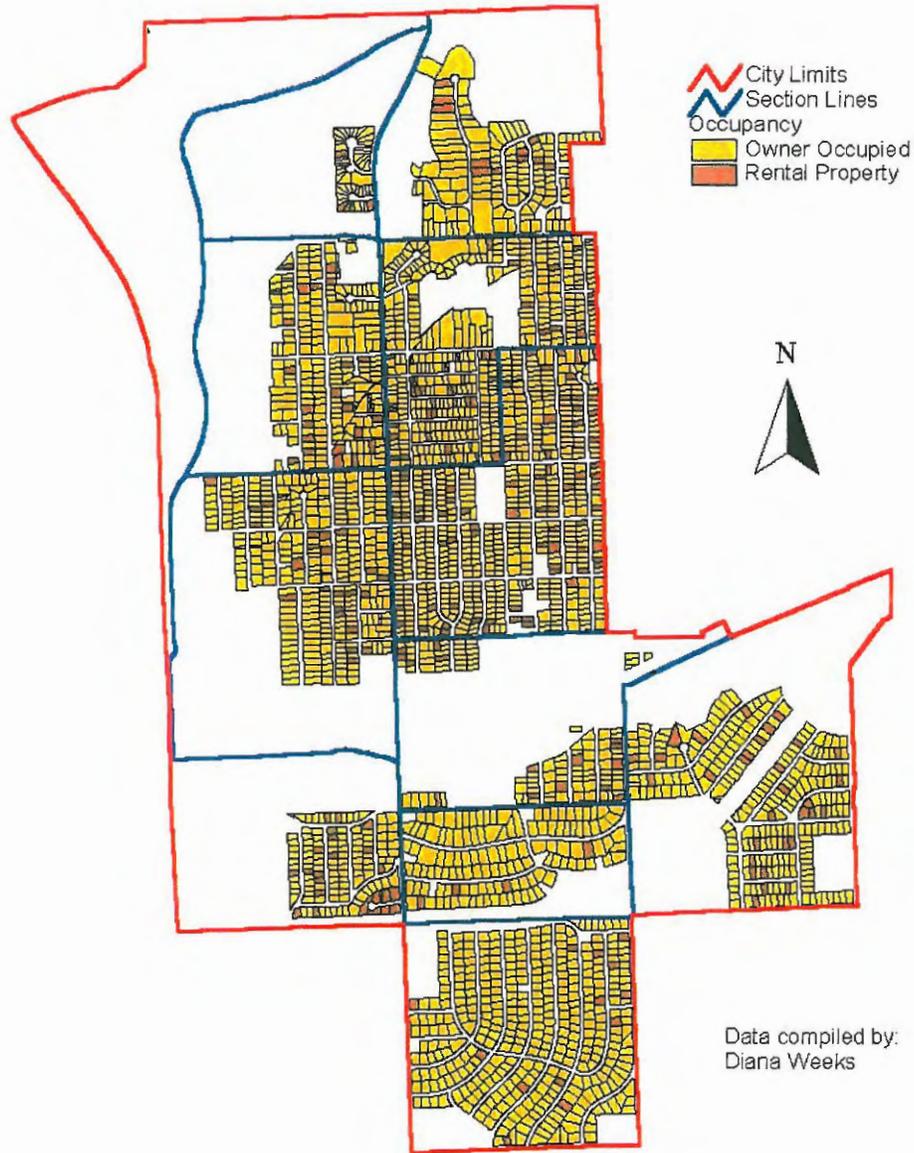
CITY OF MISSION HOUSING INVENTORY HOME OCCUPANCY

Comments: This map illustrates owner occupancy and compares it with rental properties in single and two-family residences. Data displayed here was obtained from City rental licensing records and tax records. There are no apparent trends in this illustration, other than the obvious observation that areas with lower valued properties (Example: Section 12 and 4) appear to have a higher amount of rental properties. It must be noted that out of 2621 single family residences, 238 (9.1%) are registered as rental properties. This number may be low due to incomplete City records. An additional 62 residences appear to be rental properties according to tax records. Approximately 89% of single and two family residences in the City appear to be owner-occupied.

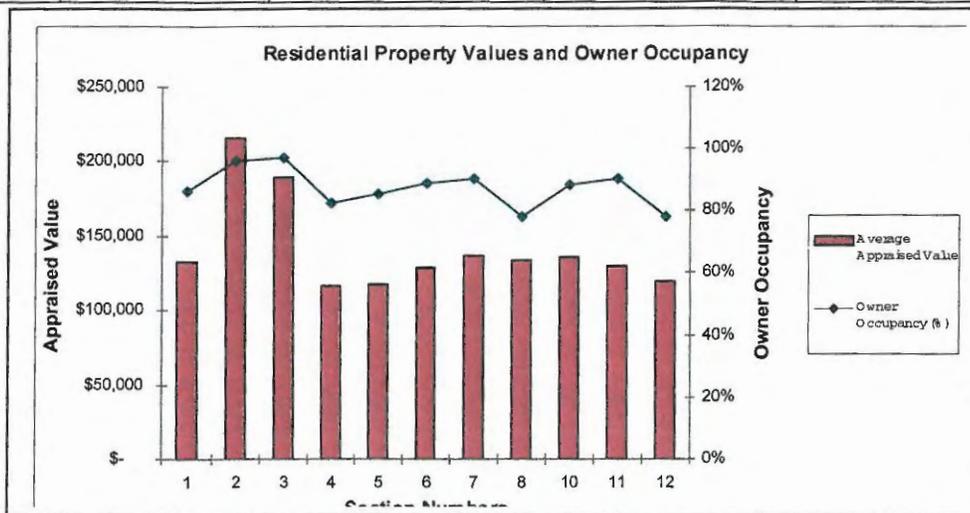
- 2) Effect of property values on quantity of owner occupied housing: Sections with highest appraised value appear to have higher proportion of owner-occupied housing. The opposite is true in sections of lower appraised property value, with the exception of Section 8, which differs from other sections because of the small number of units, all duplexes, and many of which are only considered by the County to be one 'parcel', even though they may consist of two residential units.

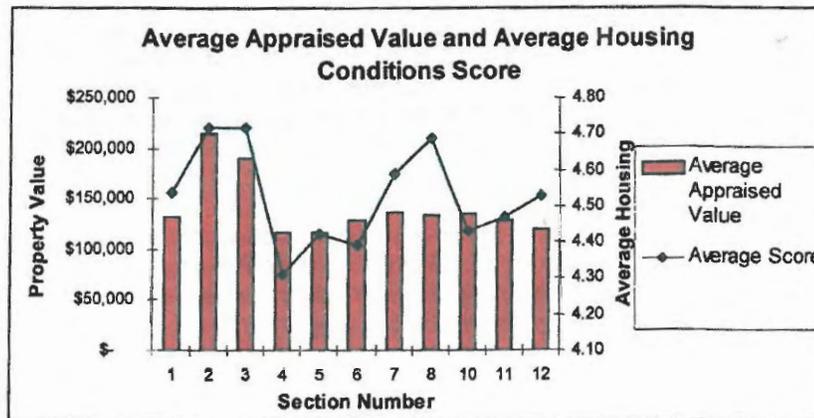
It can be noted that the Sections with the highest overall average scores are the sections with the higher average appraised value. Again, the obvious discrepancy in this statement is Section 8. This Section differs from other sections because of the small number of units, all of which are duplexes, and many of which are only considered by the County to be one 'parcel', even though they may consist of two residential units.
